Survey report

Wreck Y (SS Ossian)

North sea - N Norderney

22.09.2020

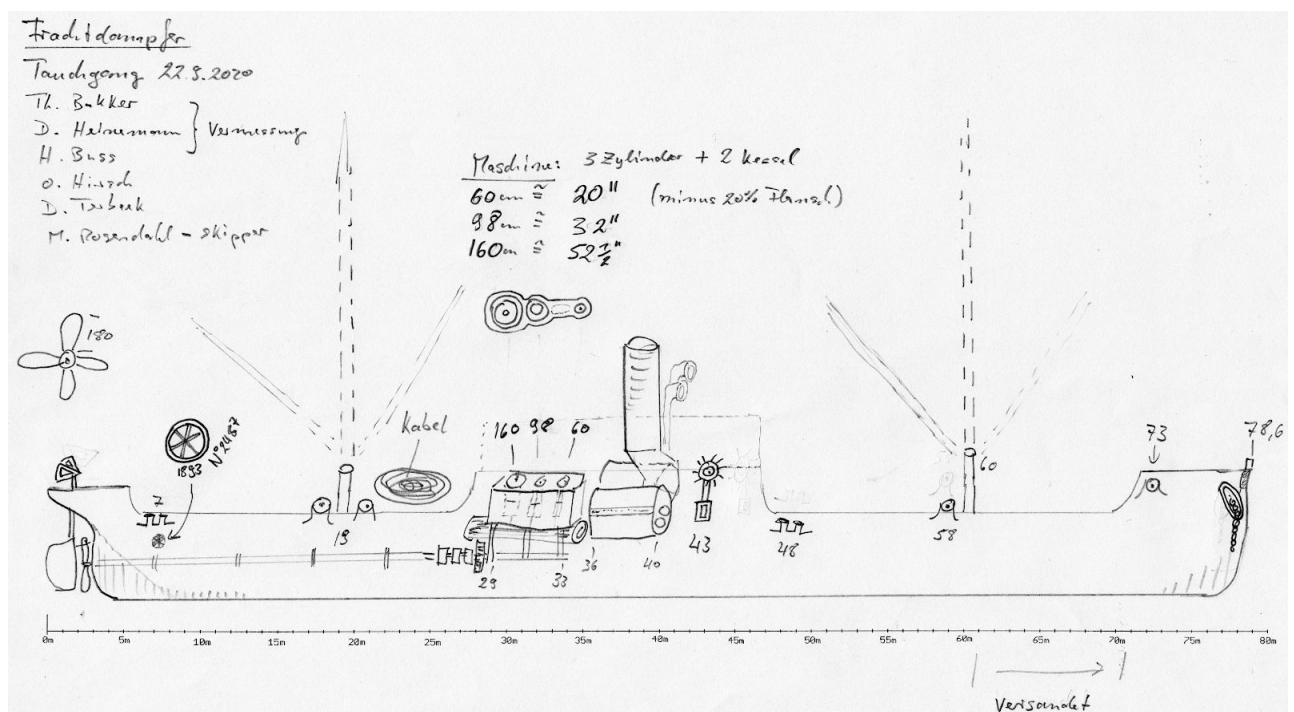
Sketch of the wreckage

It is the wreck of a riveted steel ship with a length of approx. 78,6m. It is inclined about 45 ° to starboard on a sandy bottom. The iron screw (4 blades - 1.8m each) is half silted up. The triple expansion steam engine is located in the middle of the ship about 29m from the propeller. Two boilers lie next to each other with the fire hatches (furnicases) facing the bow. The fire hatches are at 40m; so the chimney will have been exactly in the middle of the ship. At a distance of approx. 19 m from the stern there are two steam winches and a steel mast laying 20° into the direction of the bow to the starboard side. At about 23m there is a noticeably large amount of cable that was wound on a reel or drum. The cable consists of a single rubber-sheathed conductor with a small width of copper (1,5-2mm²). In addition, the cable is covered with jute and pitch (tar). The outer coating appears more tar, rather than rubber-coated. It will not be suitable for underwater. Due to the small width, it is more likely for information transfer rather than for energy transfer. Possibly it is a telegraph line. The length is estimated at a few kilometers. Amidships at approx. 43m there is a role that could have belonged to the steering gear. The round window of a brass porthole was found in the stern area with the inscription "1893 N°2457". In the bow there is a winch and the remains of a mast at about 59m. Both masts are tipped over to starboard. The area from 63 to 73m is completely silted up with sand. From about 73m from the stern we found upright parts again. The anchor fairlead is oval and no anchor was found. The front post at 78m can be seen clearly.

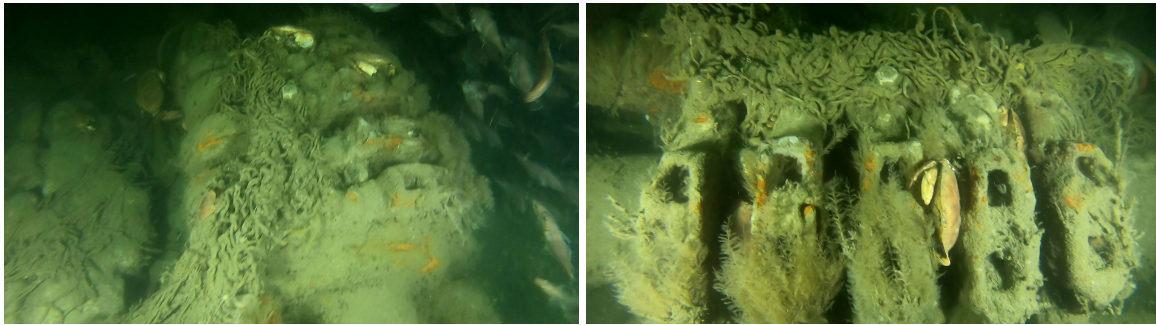
Thrust-bearing block of the propeller shaft

at 26m

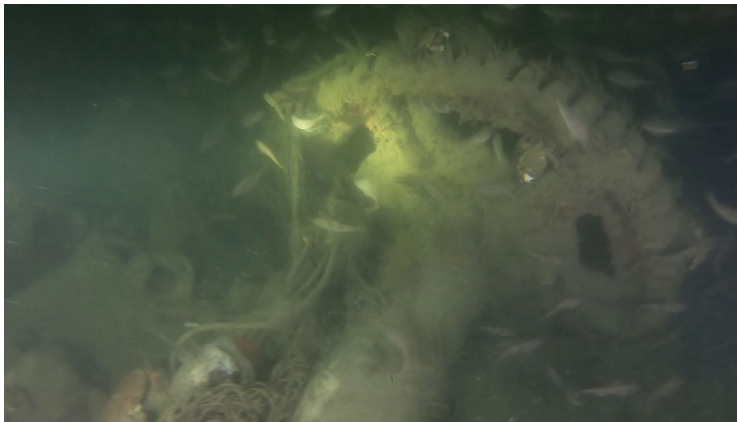
Big gear in front of the machine

At 25m

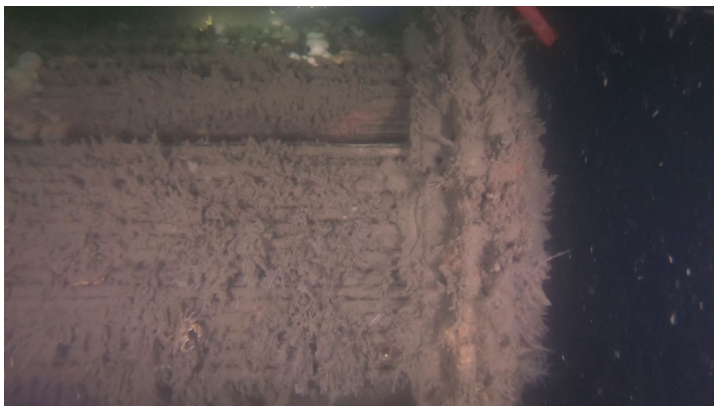
Condenser

at 29m

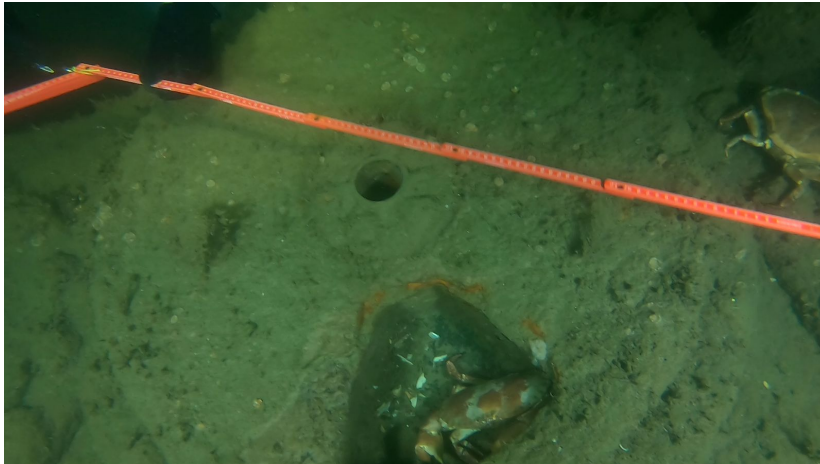
Cylinder diameters

The following dimensions of the cylinder covers were measured on the wreck:

HP: 60cm
MP: 98cm
LP: 160cm

Since the covers had a flange of approx. 20% of the diameter, the following cylinder diameters should result:

HP: 500mm = 19,7"
MP: 810mm = 32,1"
LP: 1333mm = 52,5"

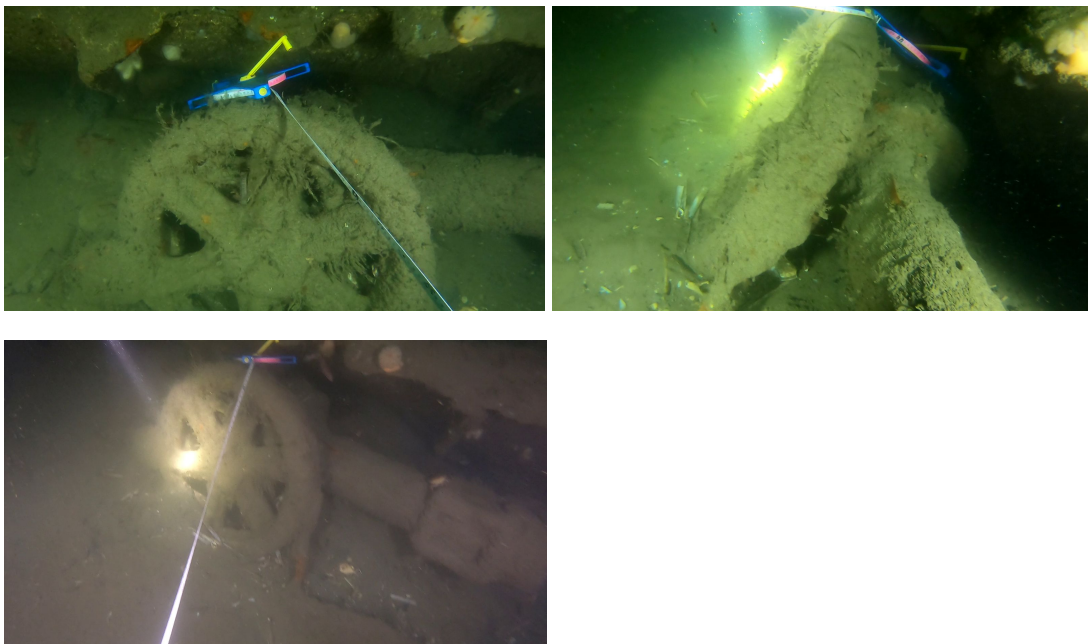
Part of the steering wheel or deflection of the steering chain

At 43m

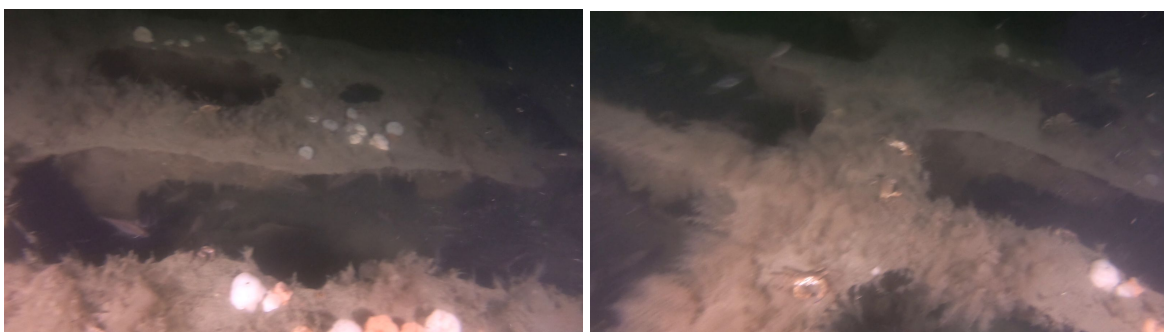
Cellular double bottom

At 54m

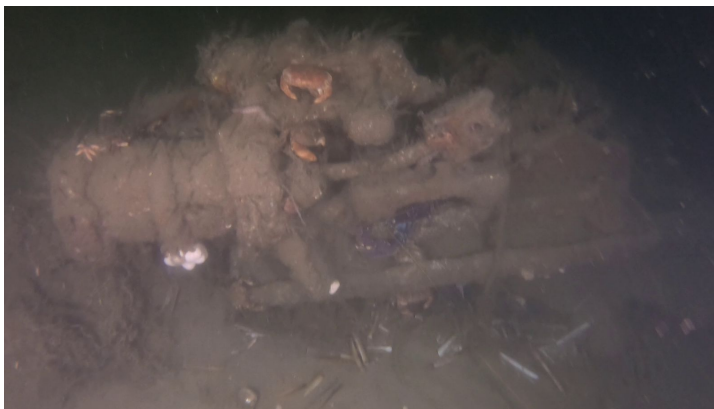
Steam winch at 59m

At 58m - capsized

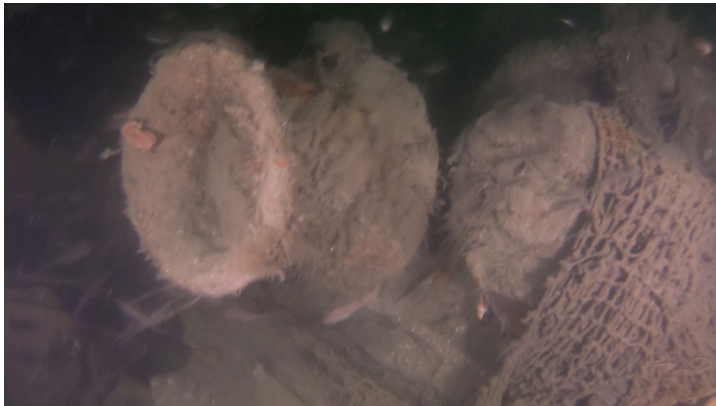
Anchor winch

At 73m

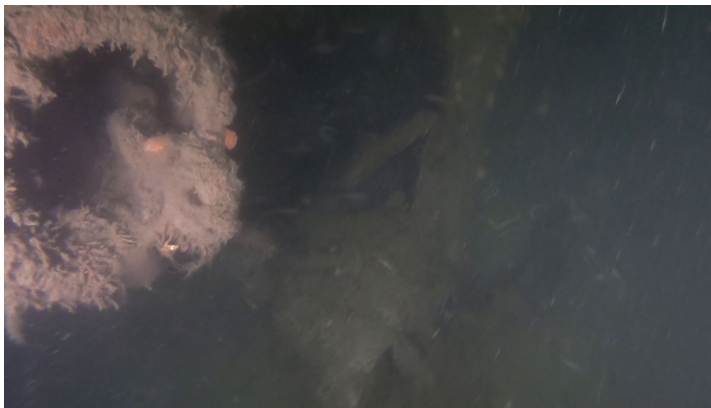
Two fairleads for the anchor chain

At 75m

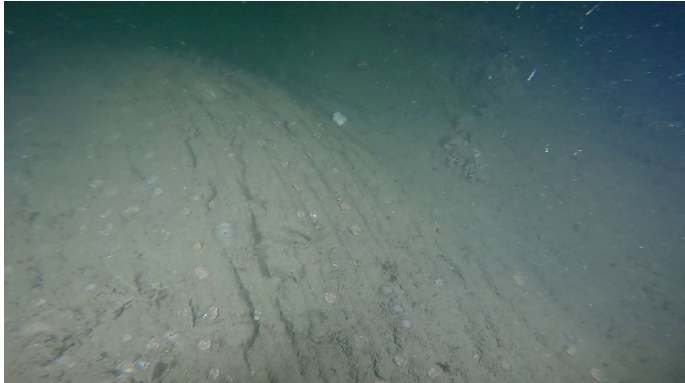
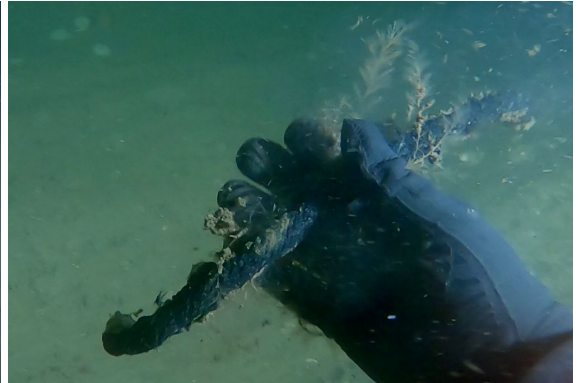
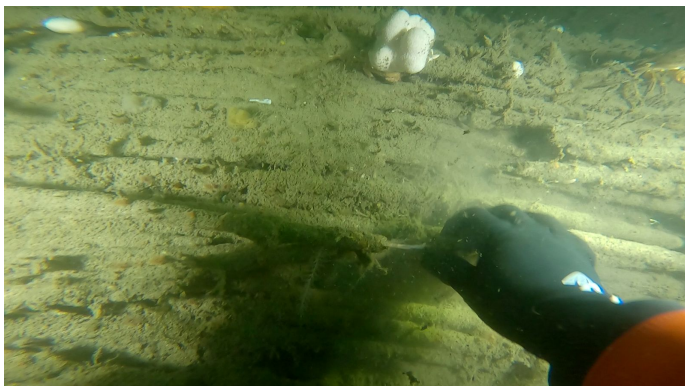
Cable

A large roll of cables was found in the rear hold - very close to the mast.

The cable consists of a single insulated copper conductor with a small copper width (1,5mm²), which is wrapped in jute.

The length is estimated at several kilometers.

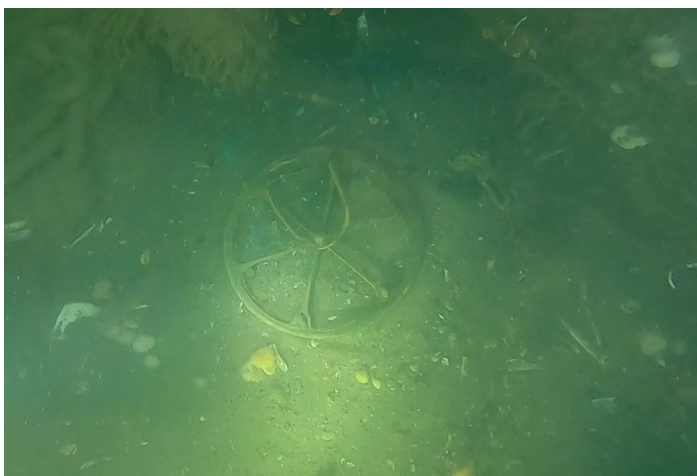
Window of a porthole

There is the inscription "**1893**" and a serial number" on it

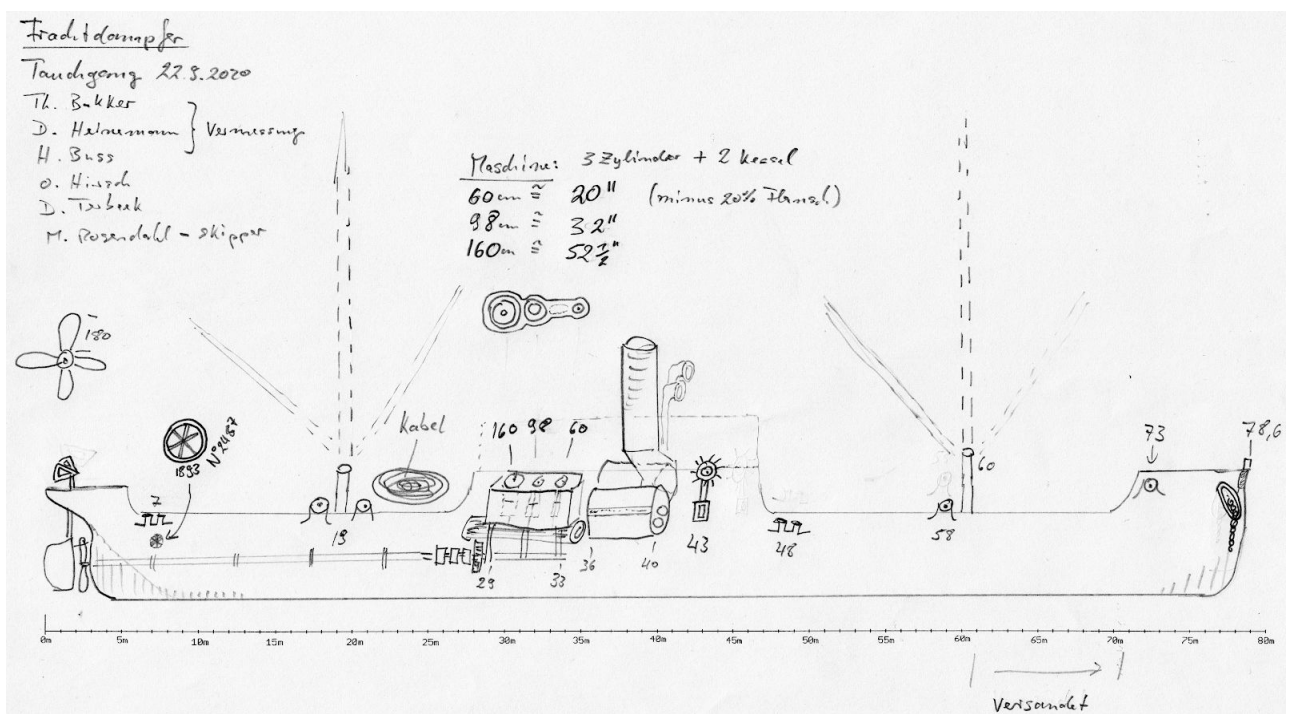
Sketch by Holger Buss

- position of the wreck
- size around 78m
- probably built around 1893
- it sunk before 2.11.1949
- size of the steam machine
 - Cylinder sizes around: 20" - 32" - 52,5"
 - most of the steamers had smaller machines like 16,5" - 26" - 42"
- position of the machine in the middle of the ship
- two masts at 19m and 60m
- Two boilers with 2*3 firing holes (furnicases) facing to the bow
