Survey report

Wreck Y (SS Ossian)

North sea - N Norderney

22.09.2020

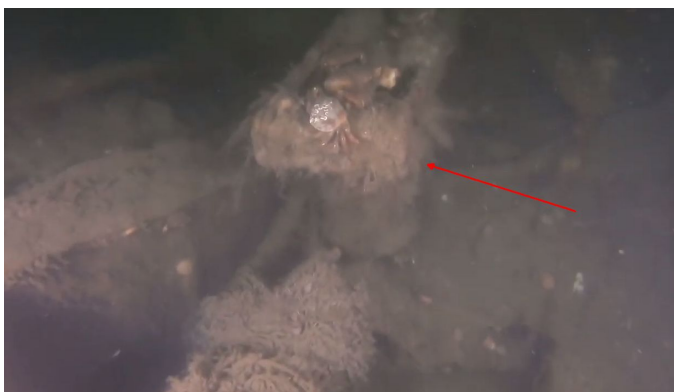
Bollard

7m from the stern. The bollard is capsized

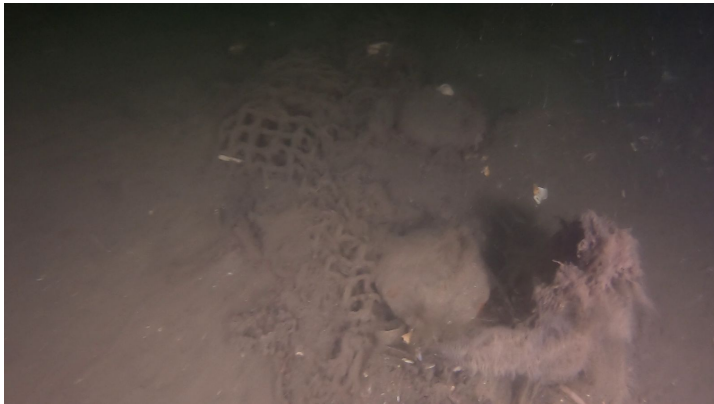
Bollard

At 48m - almost completely silted up

We can see the bollard that we found at 48m
